# Water Well Maintenance and Rehabilitation

**Water wells require regular maintenance to ensure adequate water flow and optimum water quality.**

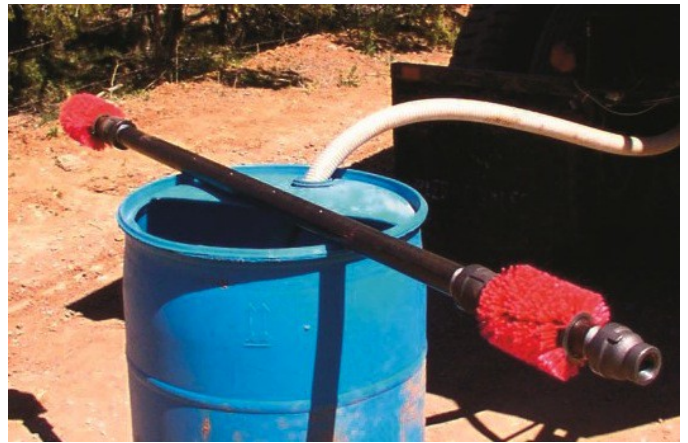
Brush to be attached to drilling rig as one method of physical rehabilitation.

Physical methods include using a brush attached to a drilling rig, high pressure jetting, hydrofracturing, and well surging.

The latter three techniques all include injecting water (and sometimes chemicals) into the well under extreme pressure. Sometimes contractors will use a combination of these methods depending upon the reason(s) for the decrease in well performance.

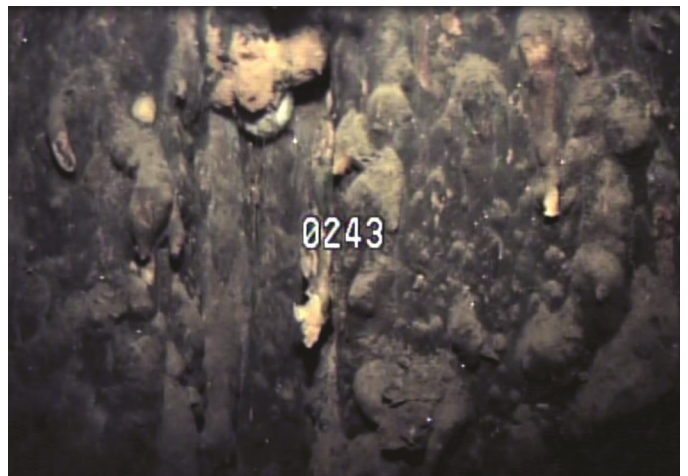
Well video image showing heavy biological and scale fouling, completely covering the screened section of the well.

In severe cases, the obstruction to flowing water can render the well useless. Major forms of incrustations can occur from build up of calcium and magnesium salts, iron and manganese compounds, or plugging caused by slime producing iron bacteria or other similar organisms (bio-fouling).

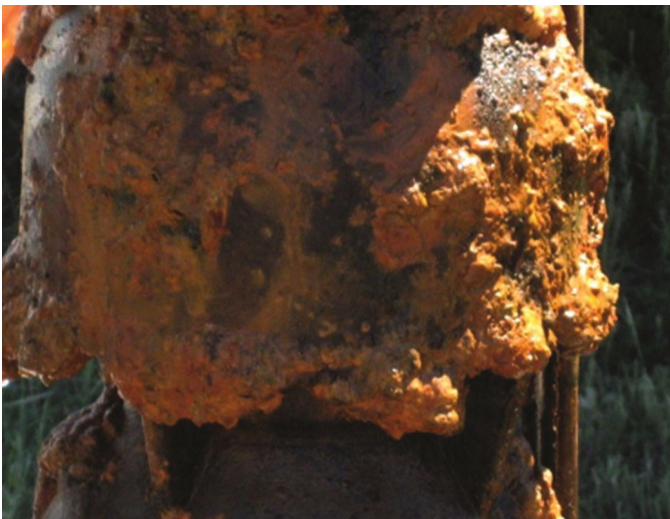
A submersible pump being pulled from a well exhibiting iron oxide, iron bacteria and biofilm.

Rapid growth of these bacteria can quickly clog well screen pores and render a well virtually useless in a matter of months. Once iron bacteria become established in a well, they are extremely difficult to eradicate.

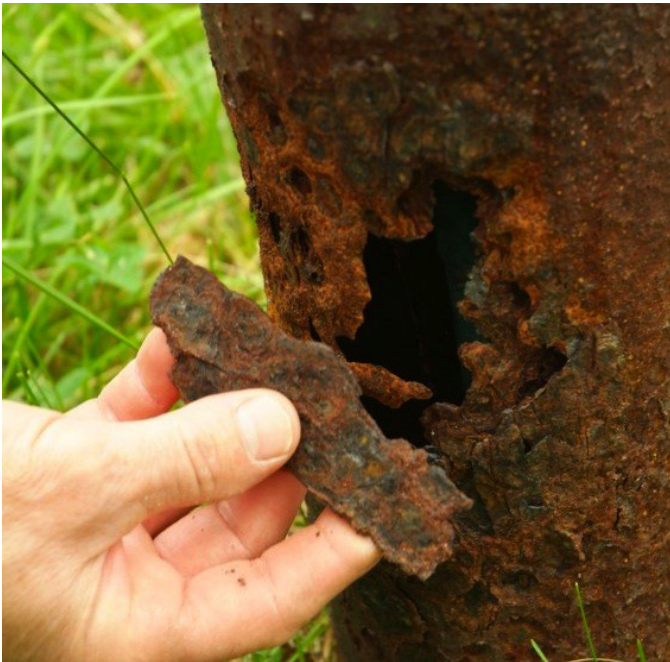
Hole in casing caused by corrosion.

Corroded and enlarged well screen holes may lead to sand pumping, which in turn results in abrasive deterioration of pump parts and enlarged screen openings leading to excessive sediment velocities.

In this case, abrasive materials carried in high velocity flows can lead to erosion of the screen openings. A screen or well casing that has undergone significant corrosive deterioration may collapse altogether. A final negative impact of well

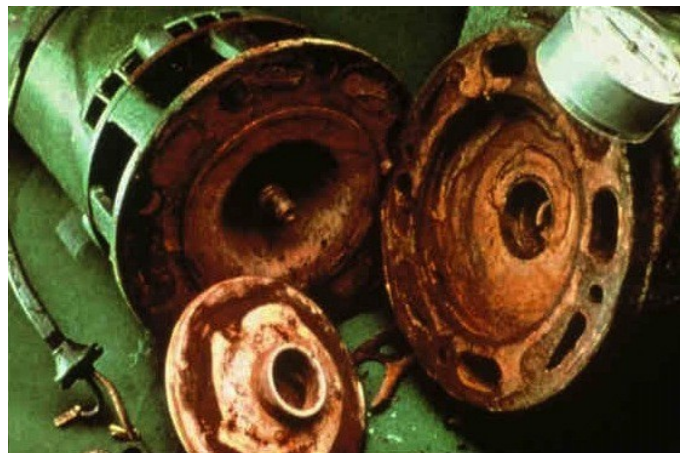
Abrasion caused by pumping sand.

Abrasive deterioration resulting from sand pumping is the leading cause of pump failure.

Excessive sediment concentrations in well water can be brought about by inadequate initial well development, absence of a well screen in a loose rock formation, oversized screen openings, excessive well screen entrance water velocities resulting from undersized openings, or well screen corrosion.
