# Water Well Maintenance and Rehabilitation

**Water wells require regular maintenance to ensure adequate water flow and optimum water quality.**

Code: ART-4024

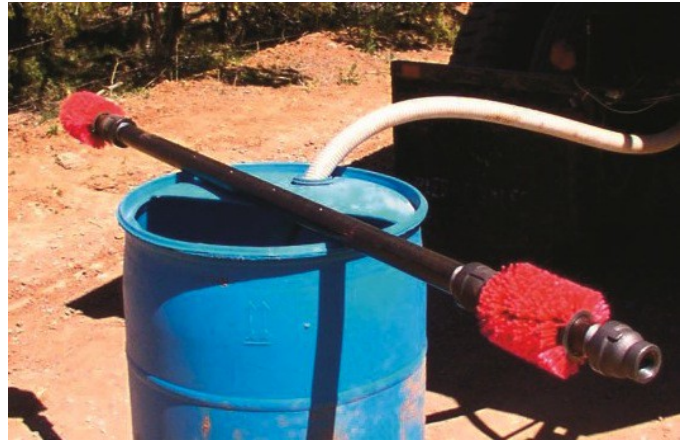
Brush to be attached to drilling rig as one method of physical rehabilitation.

Physical methods include using a brush attached to a drilling rig, high pressure jetting, hydrofracturing, and well surging.

The latter three techniques all include injecting water (and sometimes chemicals) into the well under extreme pressure. Sometimes contractors will use a combination of these methods depending upon the reason(s) for the decrease in well performance.

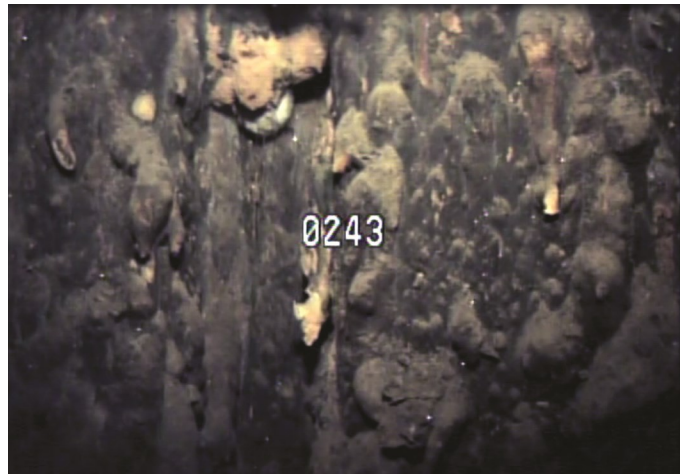
Well video image showing heavy biological and scale fouling, completely covering the screened section of the well.

In severe cases, the obstruction to flowing water can render the well useless. Major forms of incrustations can occur from build up of calcium and magnesium salts, iron and manganese compounds, or plugging caused by slime producing iron bacteria or other similar organisms (bio-fouling).

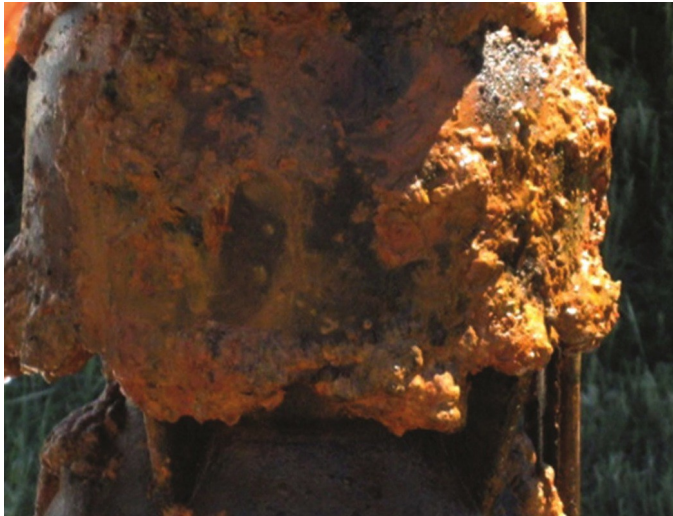
A submersible pump being pulled from a well exhibiting iron oxide, iron bacteria and biofilm.

Rapid growth of these bacteria can quickly clog well screen pores and render a well virtually useless in a matter of months. Once iron bacteria become established in a well, they are extremely difficult to eradicate.

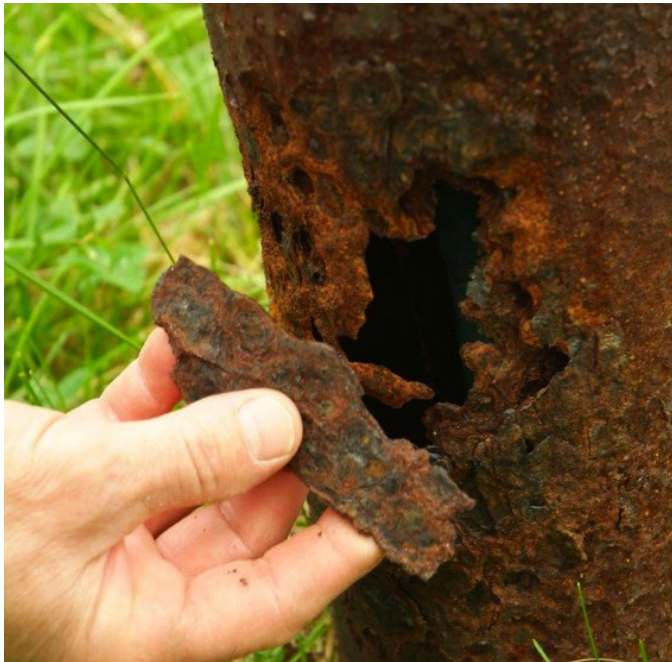
Hole in casing caused by corrosion.

Corroded and enlarged well screen holes may lead to sand pumping, which in turn results in abrasive deterioration of pump parts and enlarged screen openings leading to excessive sediment velocities.

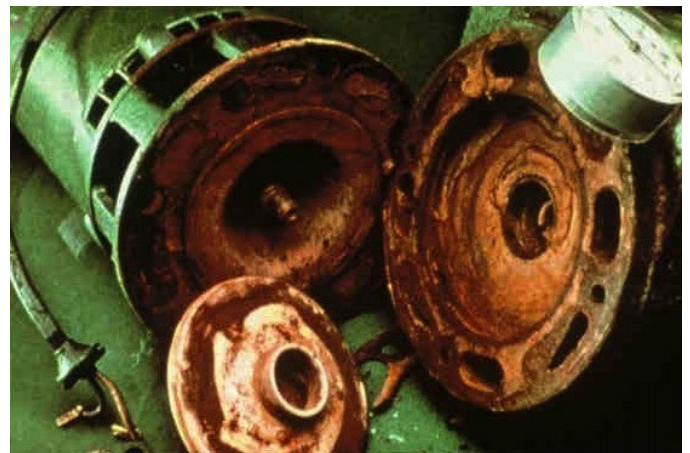
Abrasion caused by pumping sand.

Abrasive deterioration resulting from sand pumping is the leading cause of pump failure.

Excessive sediment concentrations in well water can be brought about by inadequate initial well development, absence of a well screen in a loose rock formation, oversized screen openings, excessive well screen entrance water velocities resulting from undersized openings, or well screen corrosion.
